Reclamation Quagga Mussel Activities

U.S. Department of the Interior
Bureau of Reclamation

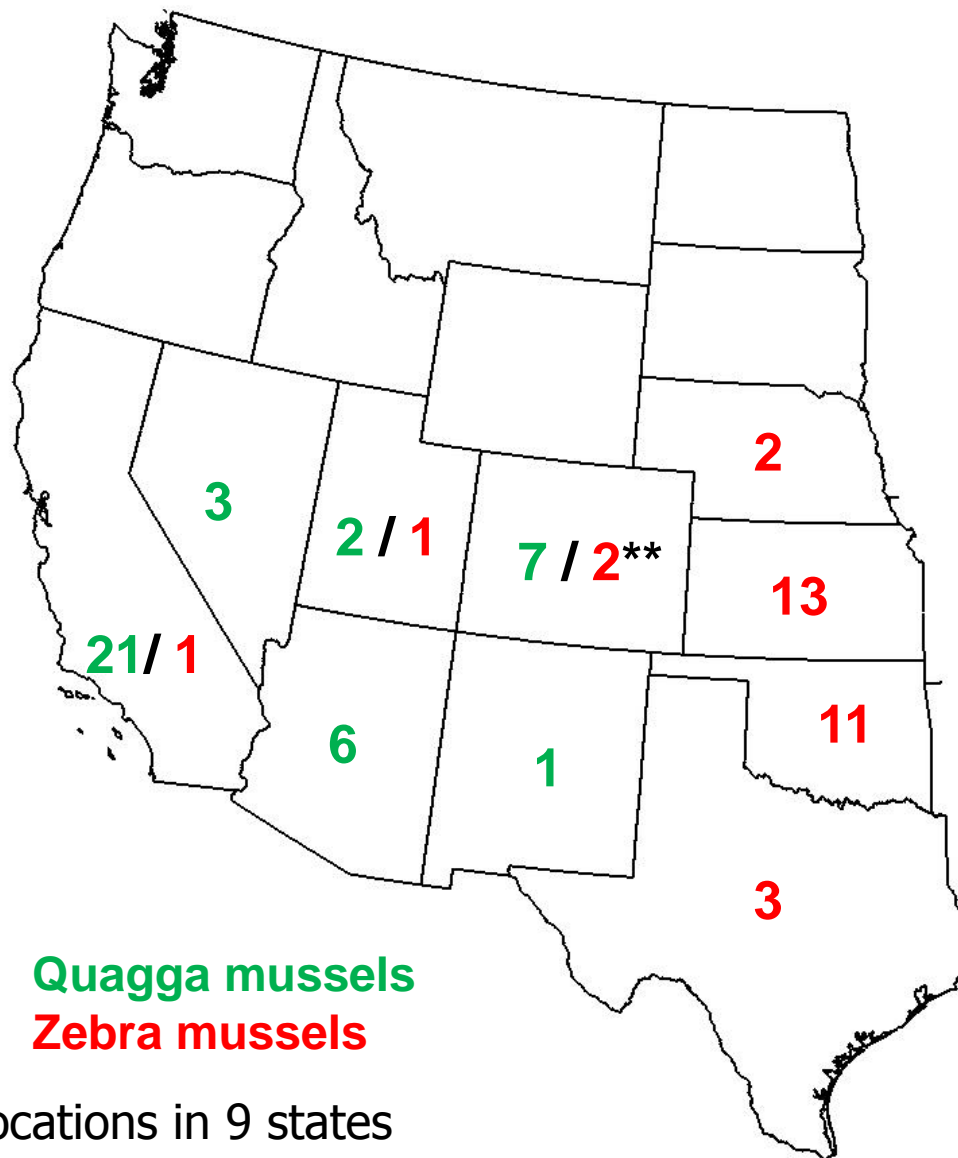
**Locations from
USGS, 1/28/13**

71 locations in 9 states

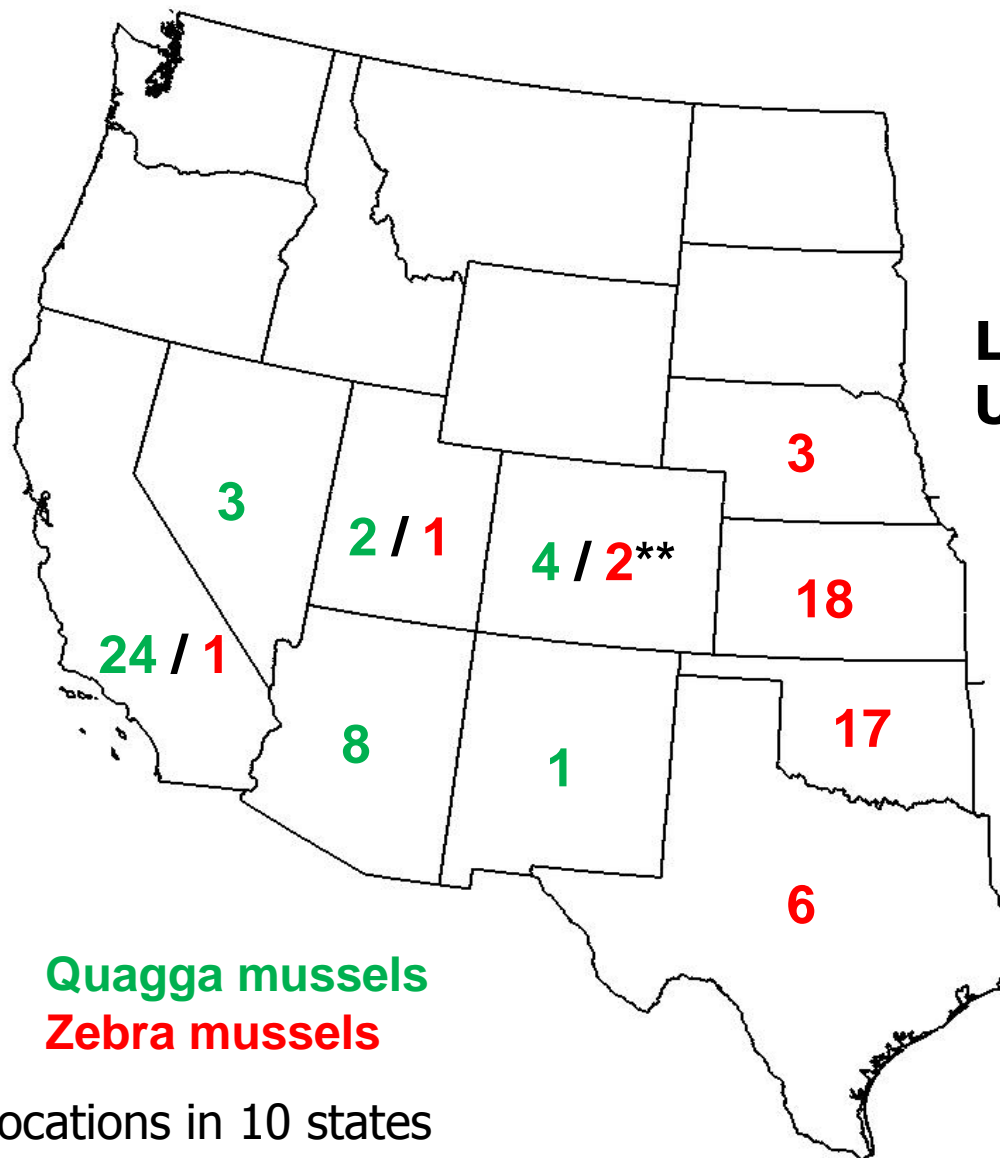
**Locations from
USGS, 10/22/13**

****Both zebra and quagga
mussels detected in Lakes
Granby and Pueblo**

88 locations in 10 states

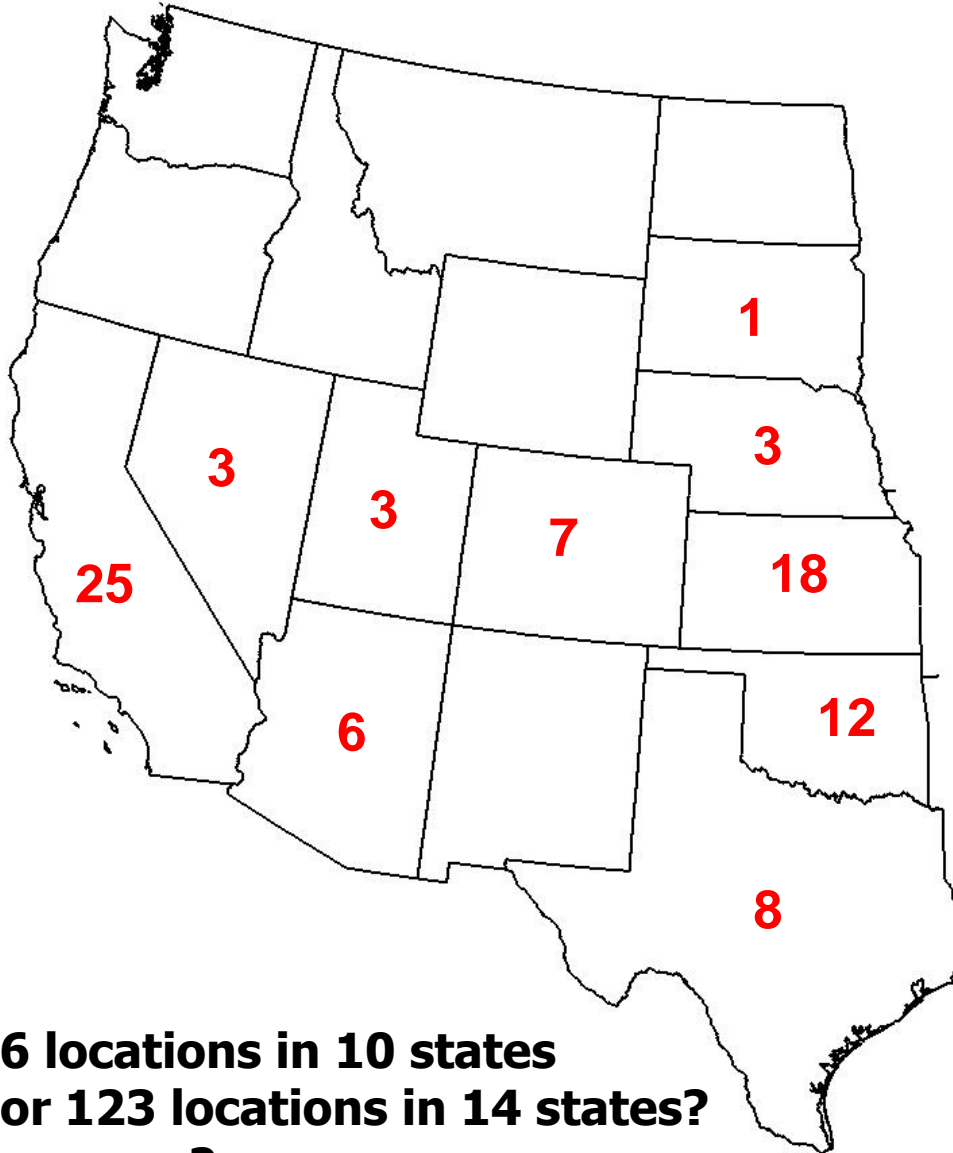
Locations from USGS, 1/13/15

86 locations in 10 states
- or 123 locations in 14 states?
- or more?

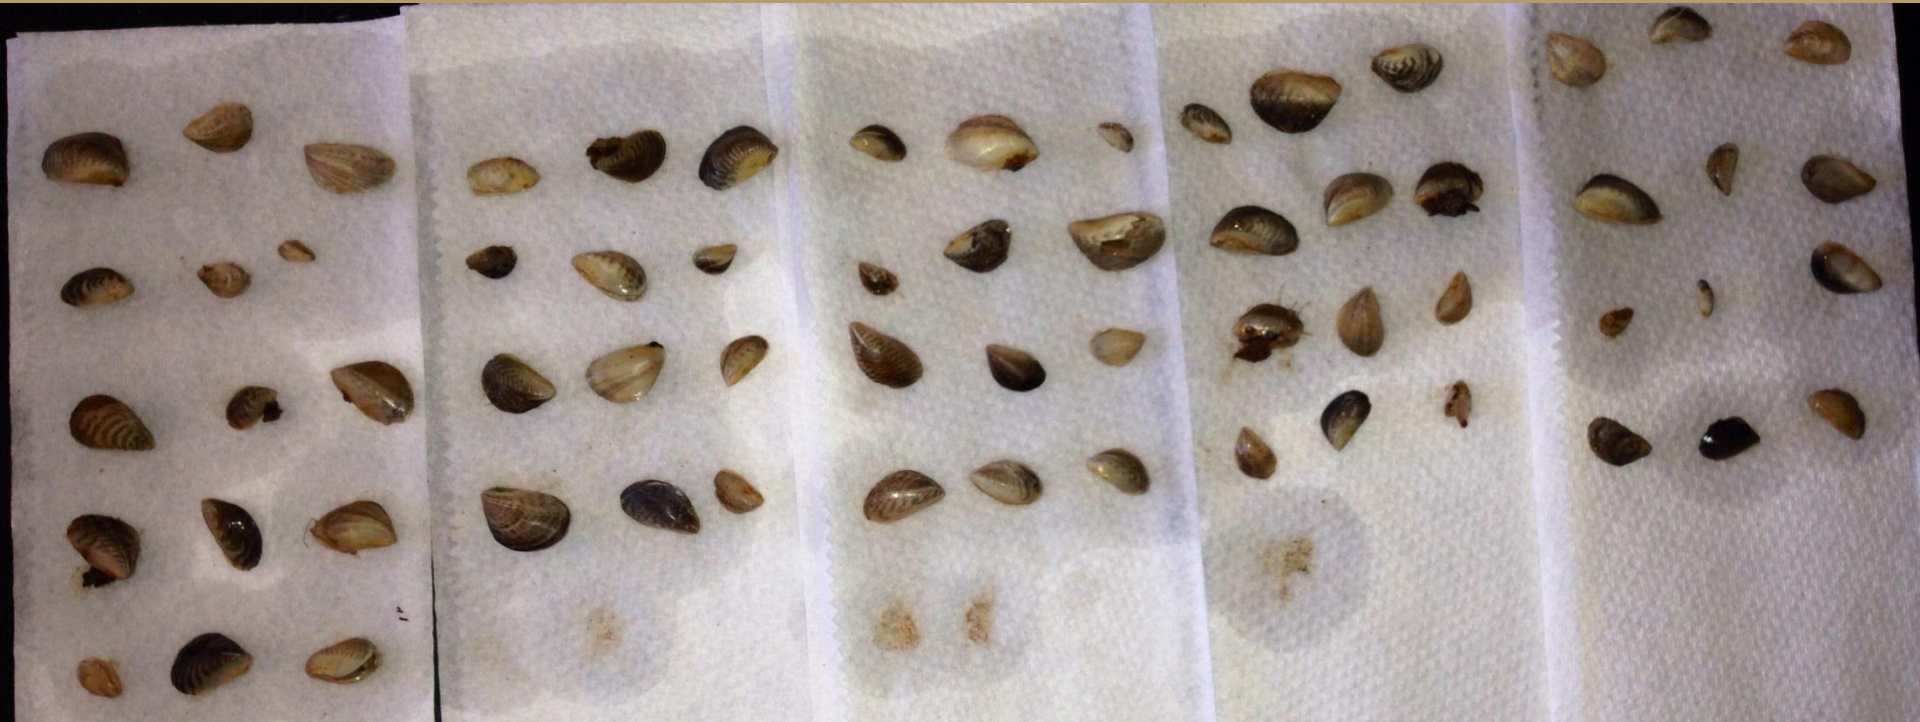
Lake Powell Penstock, 10/24/13
Estimated age = at least 3-5 years

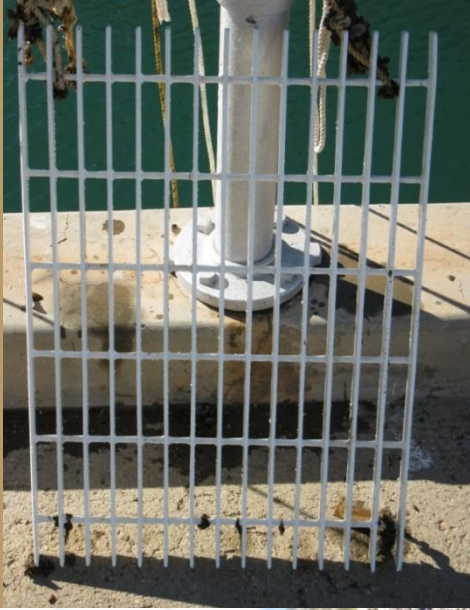
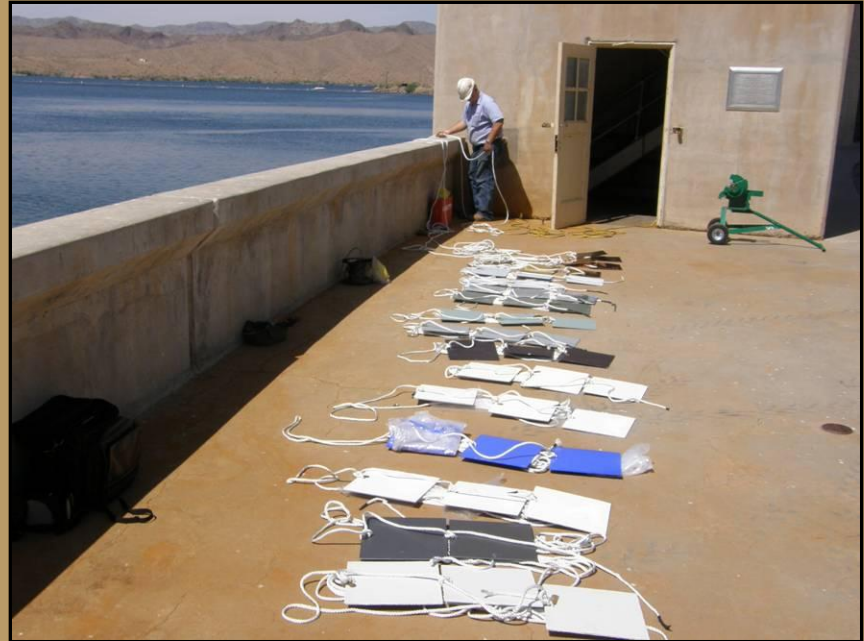
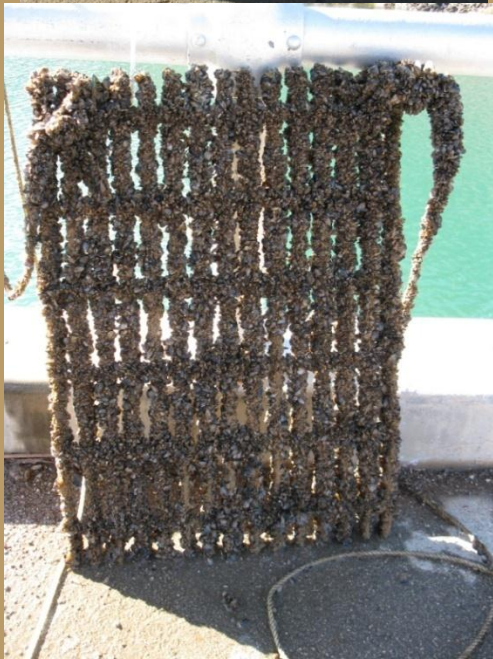
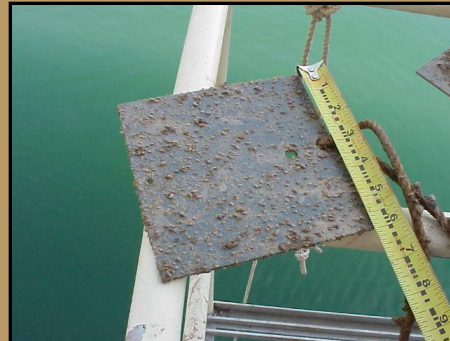
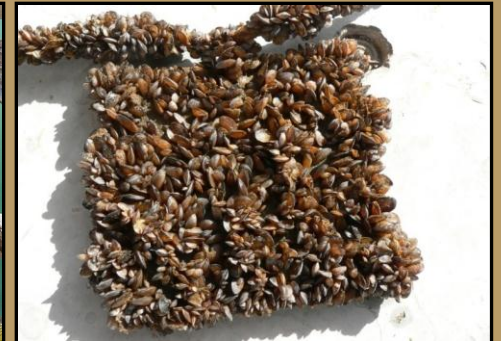
Coatings Research – Panels/Grates

- **Purpose:**
 - **Identify effective commercially available coatings products (anti-fouling & foul release)**
- **Status:**
 - **Certain commercially available coatings appear promising**
 - **Limitations with durability**
 - **Galvanizing appears effective for a relatively short period of time**
 - **Scale-up demonstrations under service conditions are underway**

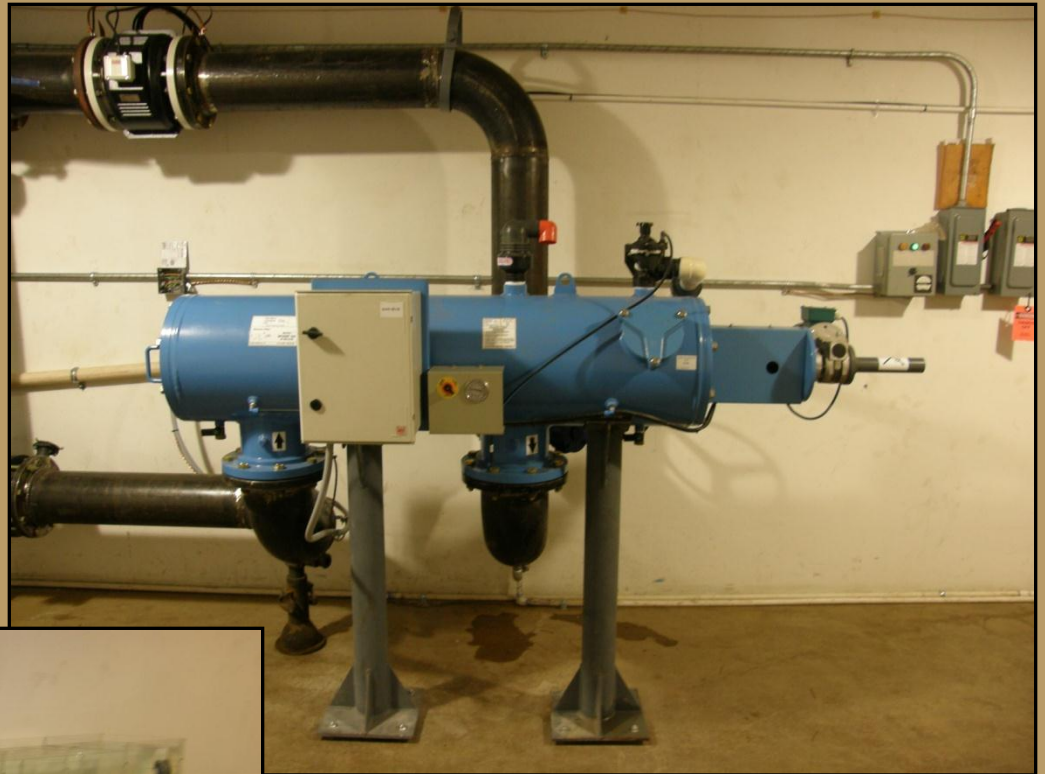
Parker Installation

Installed ballast filter

- **Ballast filter installed at Parker Dam in 2009**
- **Higher capacity filters tested at Hoover Dam**
- **Filters can remove veligers in critical areas**

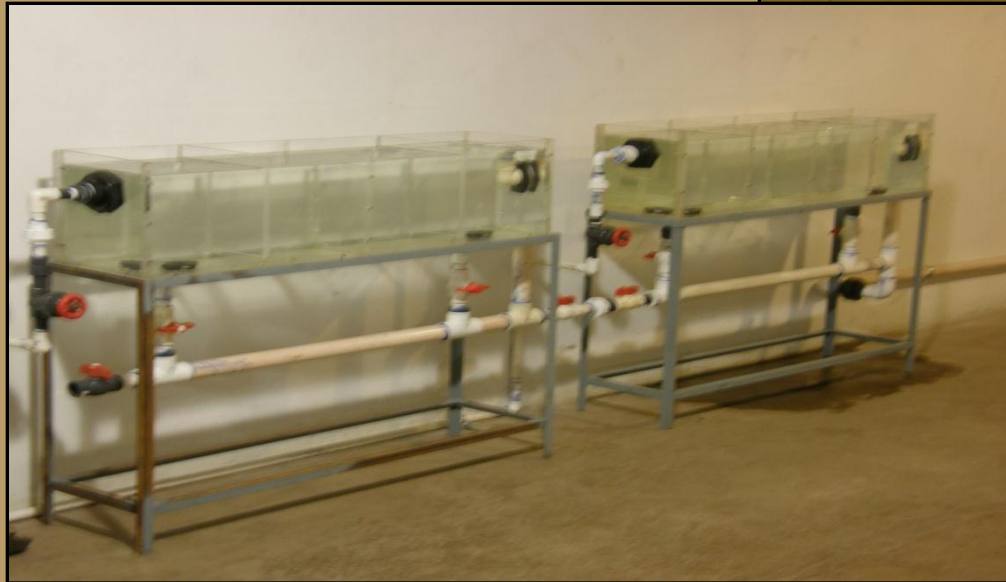
**Bio-boxes for test
evaluation**

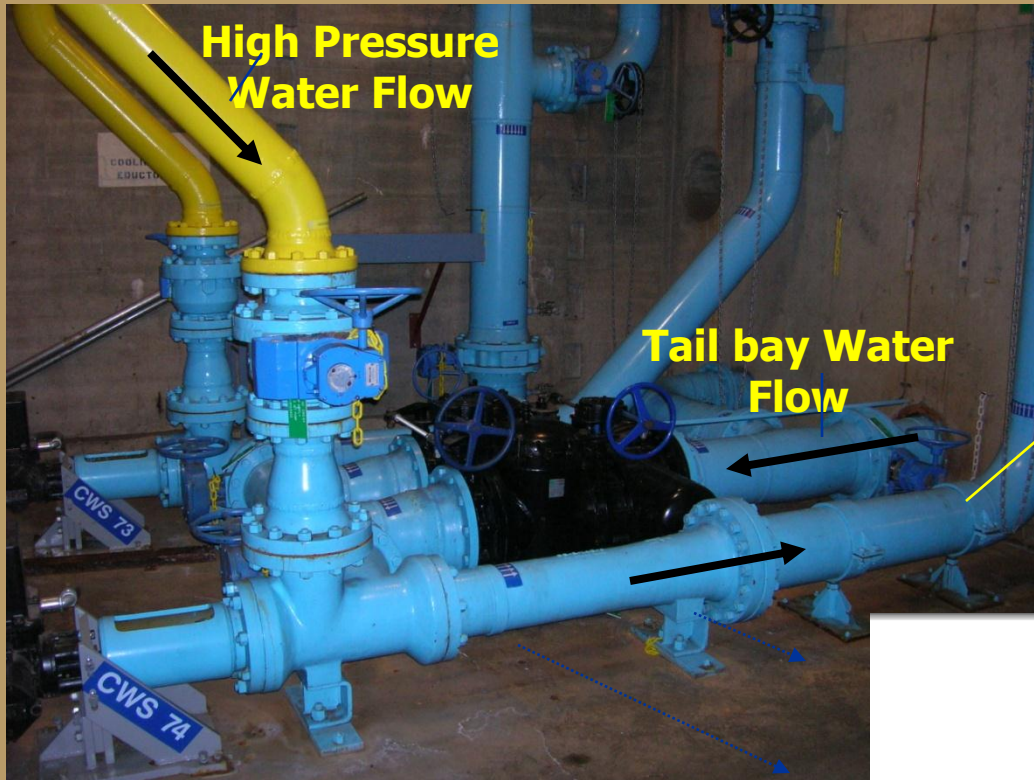
Combined Unit Cooling Water Supply

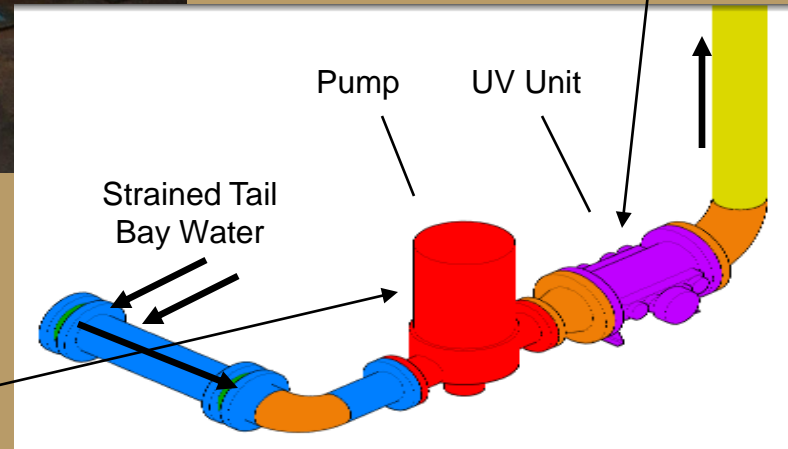
New design uses tailbay water supply instead of forebay for pumps at Hoover Dam
